Manhole Inspection Summary

Manhole # S39C2_008MH

Location Address: **4044 6th St**

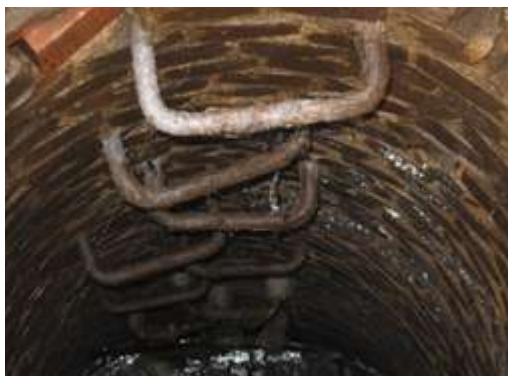
Count: **10** Missing: **0** ☒ **Corroded**

steps

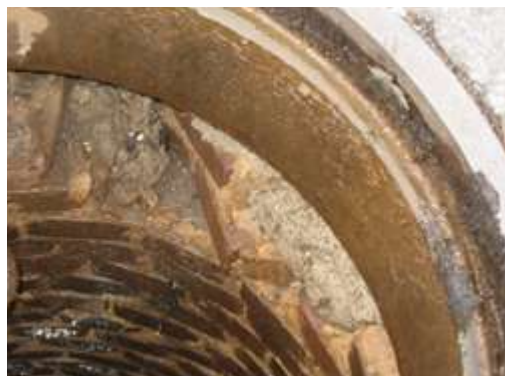
Defect 1

Condition: ☐ Sound ☐ Cracked ☐ Root Intrusion ☒ **Loose Brick** ☐ Deteriorated

Infiltration: ☐ None ☐ Joint ☐ Cracks ☒ **Mortar** ☐ Roots ☐ Wall

loose and missing bricks under frame

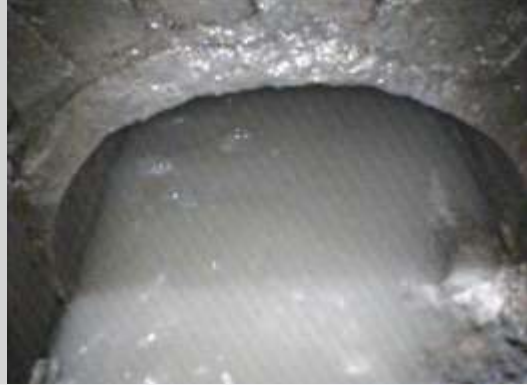
12 O'Clock Outflow

Pipe Height: **18** (in.) Rod and Bar (Angled)
Pipe Material: **Clay** ☐ Pipe Lined
Invert Depth: **15.50** (ft.) Flow Characteristics: **Fast**
Deposits: ☒ None ☐ Mud ☐ Sludge ☐ Debris ☐ Grease
Silt Depth: (in.) Deposits Extent:
Infiltration: **None** Pipe Seal Cond: **Sound**

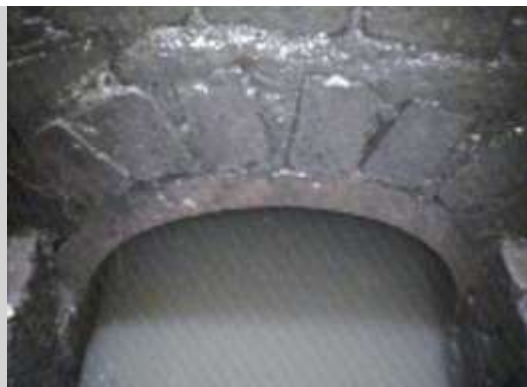
6 O'Clock Inflow

Pipe Height: **18** (in.) Rod and Bar (Angled)
Pipe Material: **Clay** ☐ Pipe Lined
Invert Depth: **15.56** (ft.) Flow Characteristics: **Fast**
Deposits: ☒ None ☐ Mud ☐ Sludge ☐ Debris ☐ Grease
Silt Depth: (in.) Deposits Extent:
Infiltration: **None** Pipe Seal Cond: **Sound**

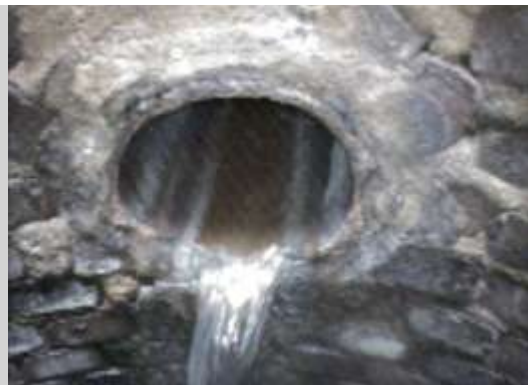
9 O'Clock Inflow

Pipe Height: **10.8** (in.) Rod and Bar (Angled)

Drop: Outside	Rod and Bar
Angled: Yes	Reading: 13.42 (ft.)
	Inv Depth: 14.42 (ft.)
Drop Condition: Open
